Full-field Deformation Measurement Techniques for a Rotating Composite Shaft

Lee W. Kohlman¹, Charles R. Ruggeri¹,
Richard E. Martin², Gary D. Roberts¹,
Robert F. Handschuh¹

¹NASA Glenn Research Center

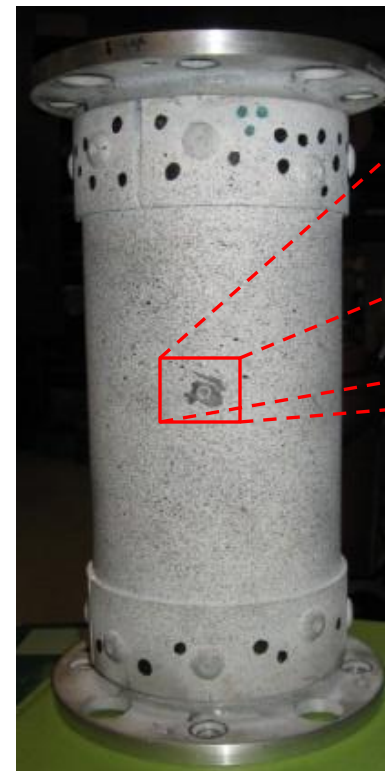
Two low speed impacts were performed using a 1/4" steel ball bearing to induce delamination in the composite tube.

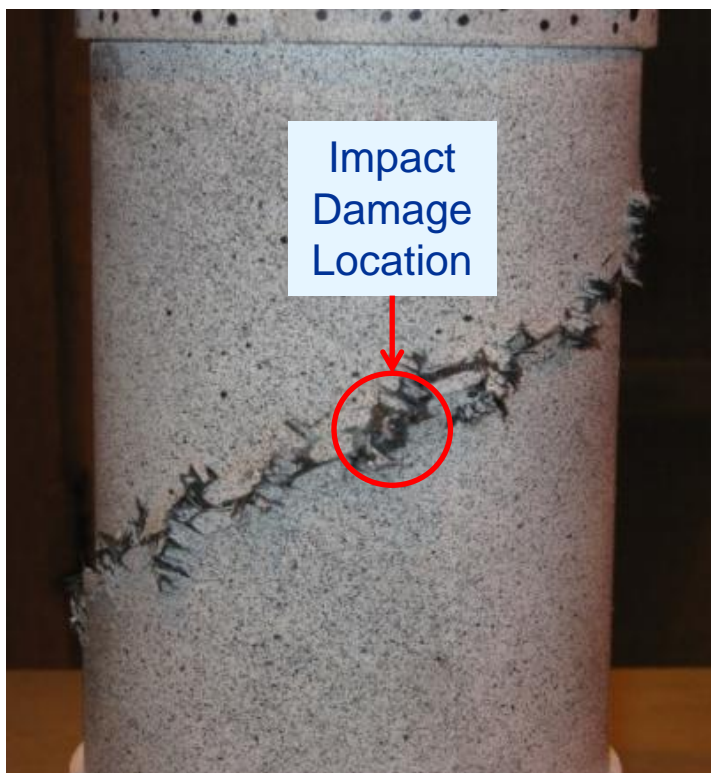
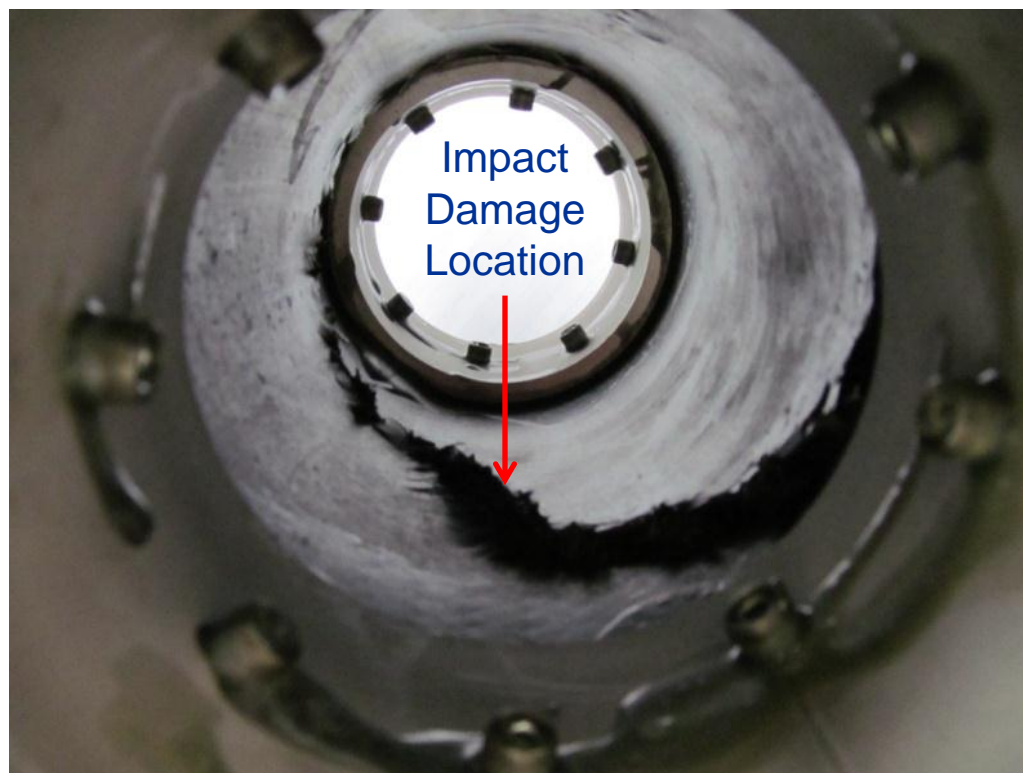
Failed Tube

- Local buckling and delamination resulted in shear failure of the composite tube

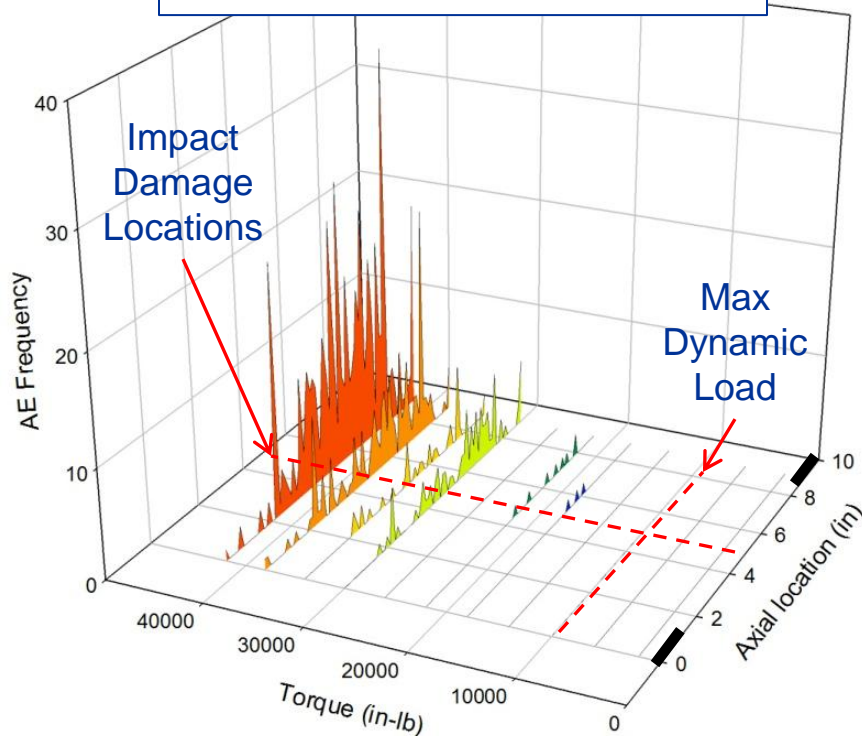
Axial Location of AE Events

- Acoustic emission agrees with the development of additional damage at the impact damage locations
- Near higher loading, damage also occurs in attachment region

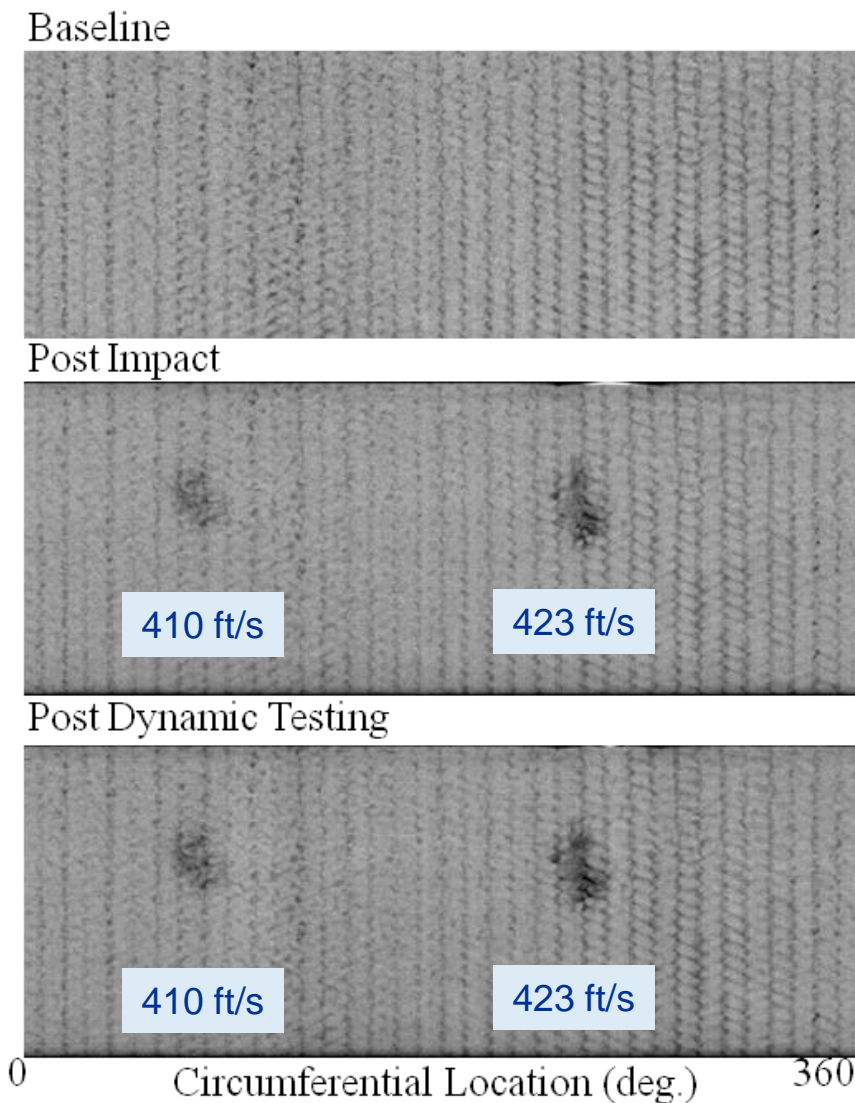
X-ray CT Observation of Damage

- No damage growth was observed following the dynamic test of the damaged tube
- Failure of the tube in the static test corresponded to the more severe damage observed by X-ray CT and higher impact velocity
